PASSAIC RIVER BASIN

LAKE VALHALLA DAM

PHASE I INSPECTION REPORT NATIONAL DAM SAFETY PROGRAM

NJ 00330

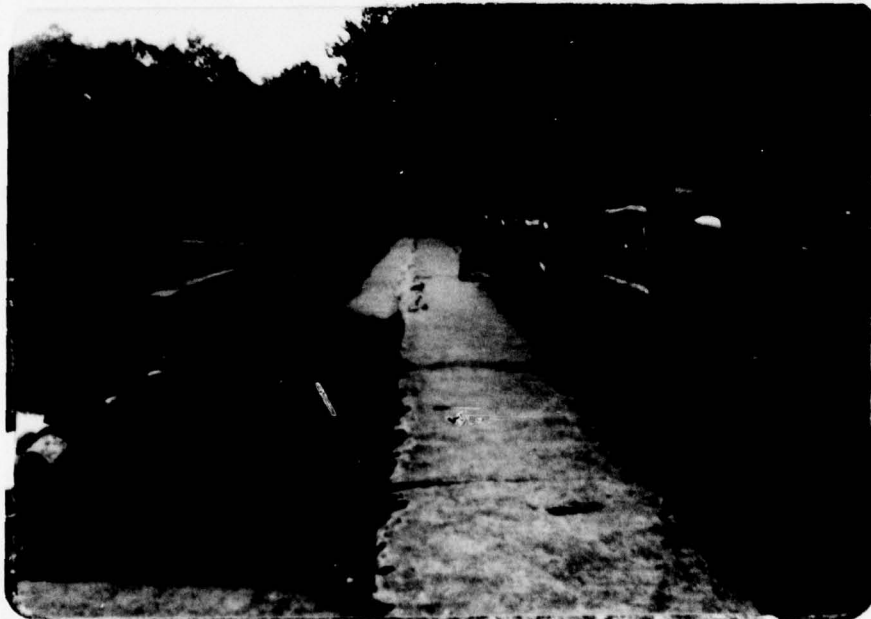
The embankment and spillway appear to be stable with no indications of failure of the dam and appurtenances. The masonry core wall appears intact and without vertical or horizontal deflection. The earth embankment on both sides of the core wall has settled one to three inches below the top of the wall.

Top of core wall in left embankment
looking east

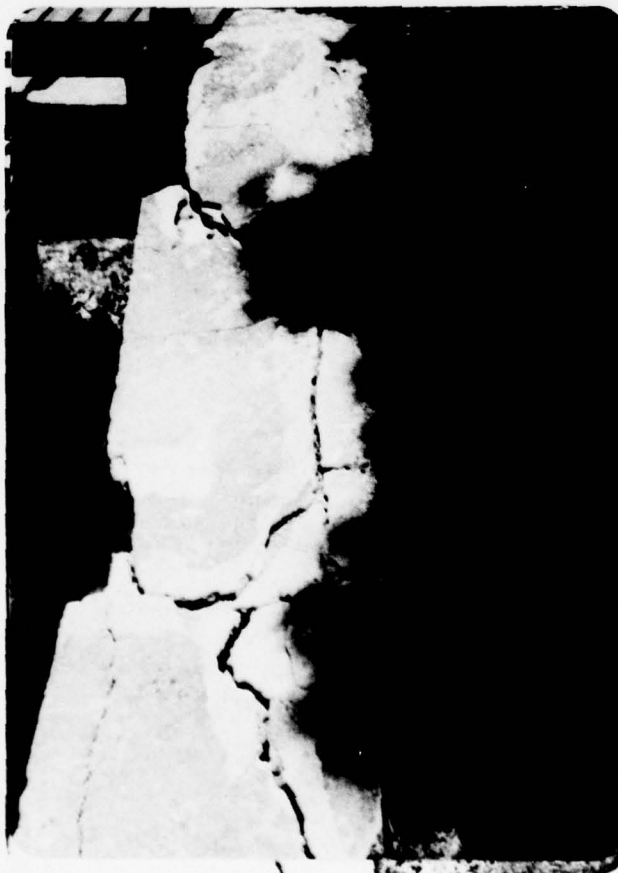
Deterioration of
upstream spillway
right sidewall.

5. Repair and strengthen the side walls of the spillway. This should be done very soon.
6. Provisions should be made to prevent floating debris, boats, etc. from plugging the free space between the bridge and the top of the spillway. This should be done very soon.
